**HYDROGEN GAS PRESSURE VESSEL
PROBLEMS IN THE M-1 FACILITIES**

by J. S. Laws, V. Frick, and J. McConnell

Prepared by
AEROJET-GENERAL CORPORATION
Sacramento, Calif.
for Lewis Research Center

NATIONAL AERONAUTICS AND SPACE ADMINISTRATION • WASHINGTON, D. C. • MARCH 1969

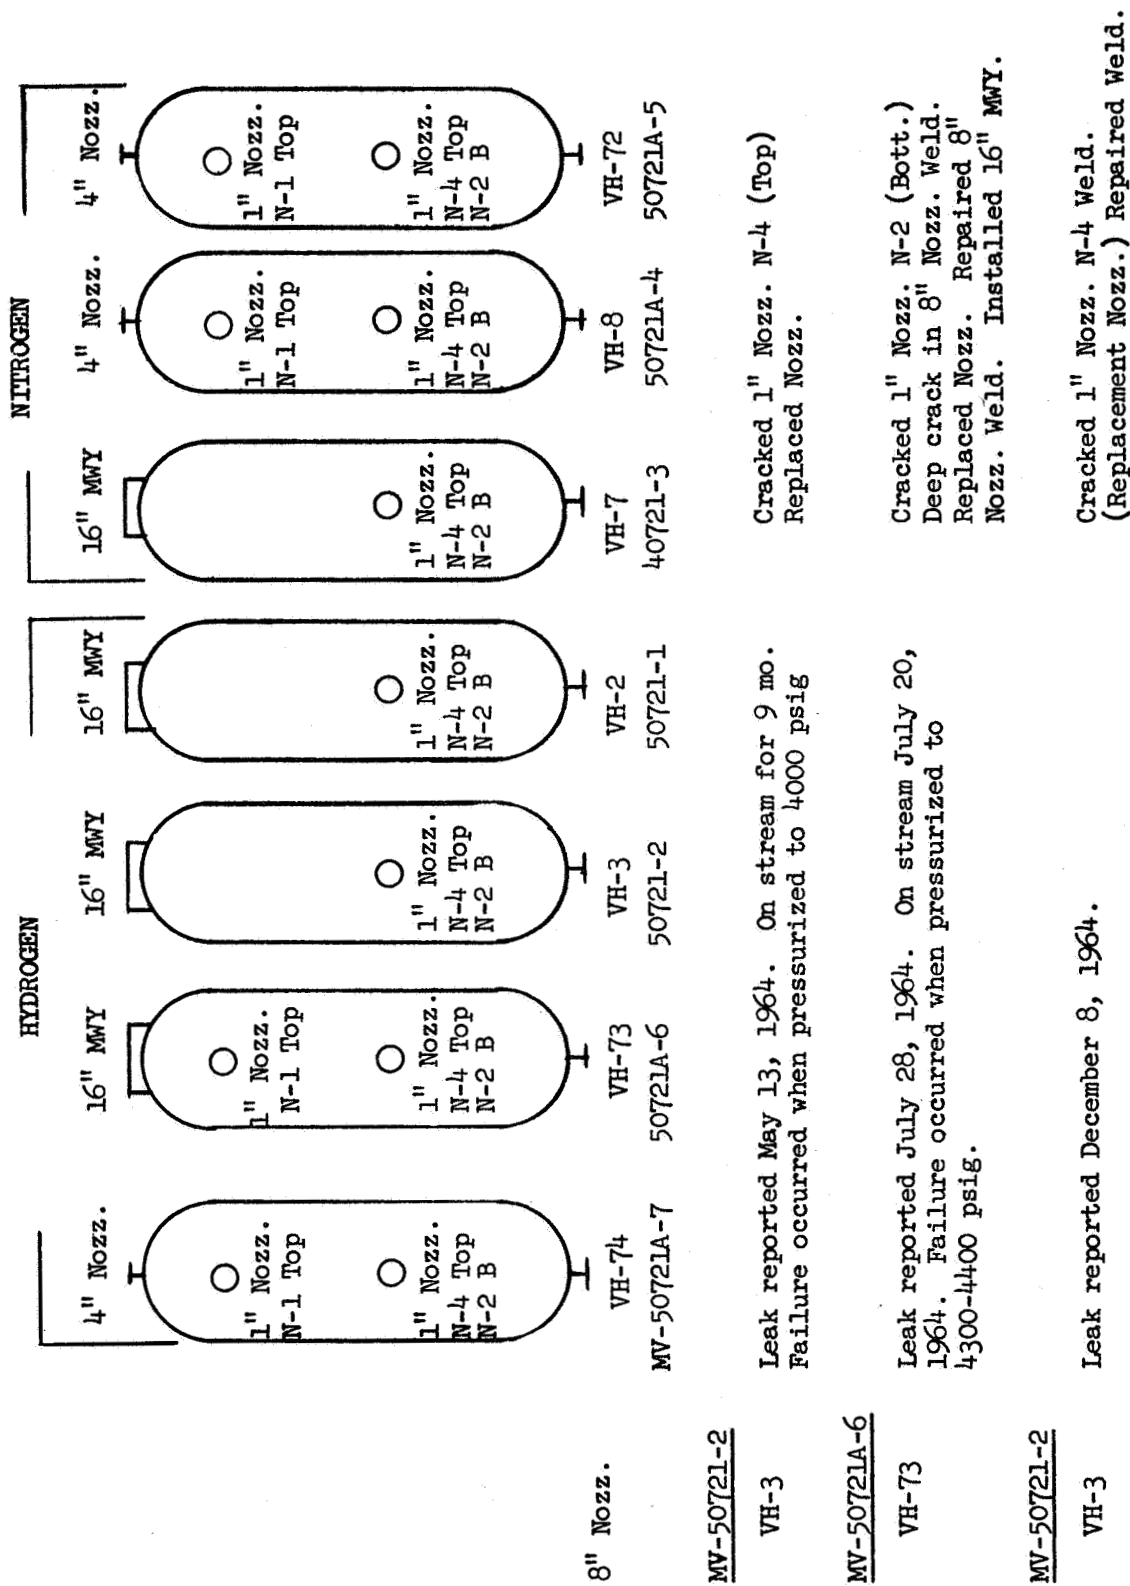
Figure 4
H-8 Test Stand, Vessel Leak History

The tanks received from A. O. Smith Corp. were placed in service between September 1963 and July 1964. Since that time, three of the vessels placed in hydrogen service have developed a total of four leaks (see Figure No. 4). All of these leaks have been in the 1-in. nozzle or the associated weldment, located near the discharge end of the vessel. A crack also was detected in an 8-in. nozzle weld in a hemispherical head. This crack did not penetrate the entire weld nor did it cause tank leakage.

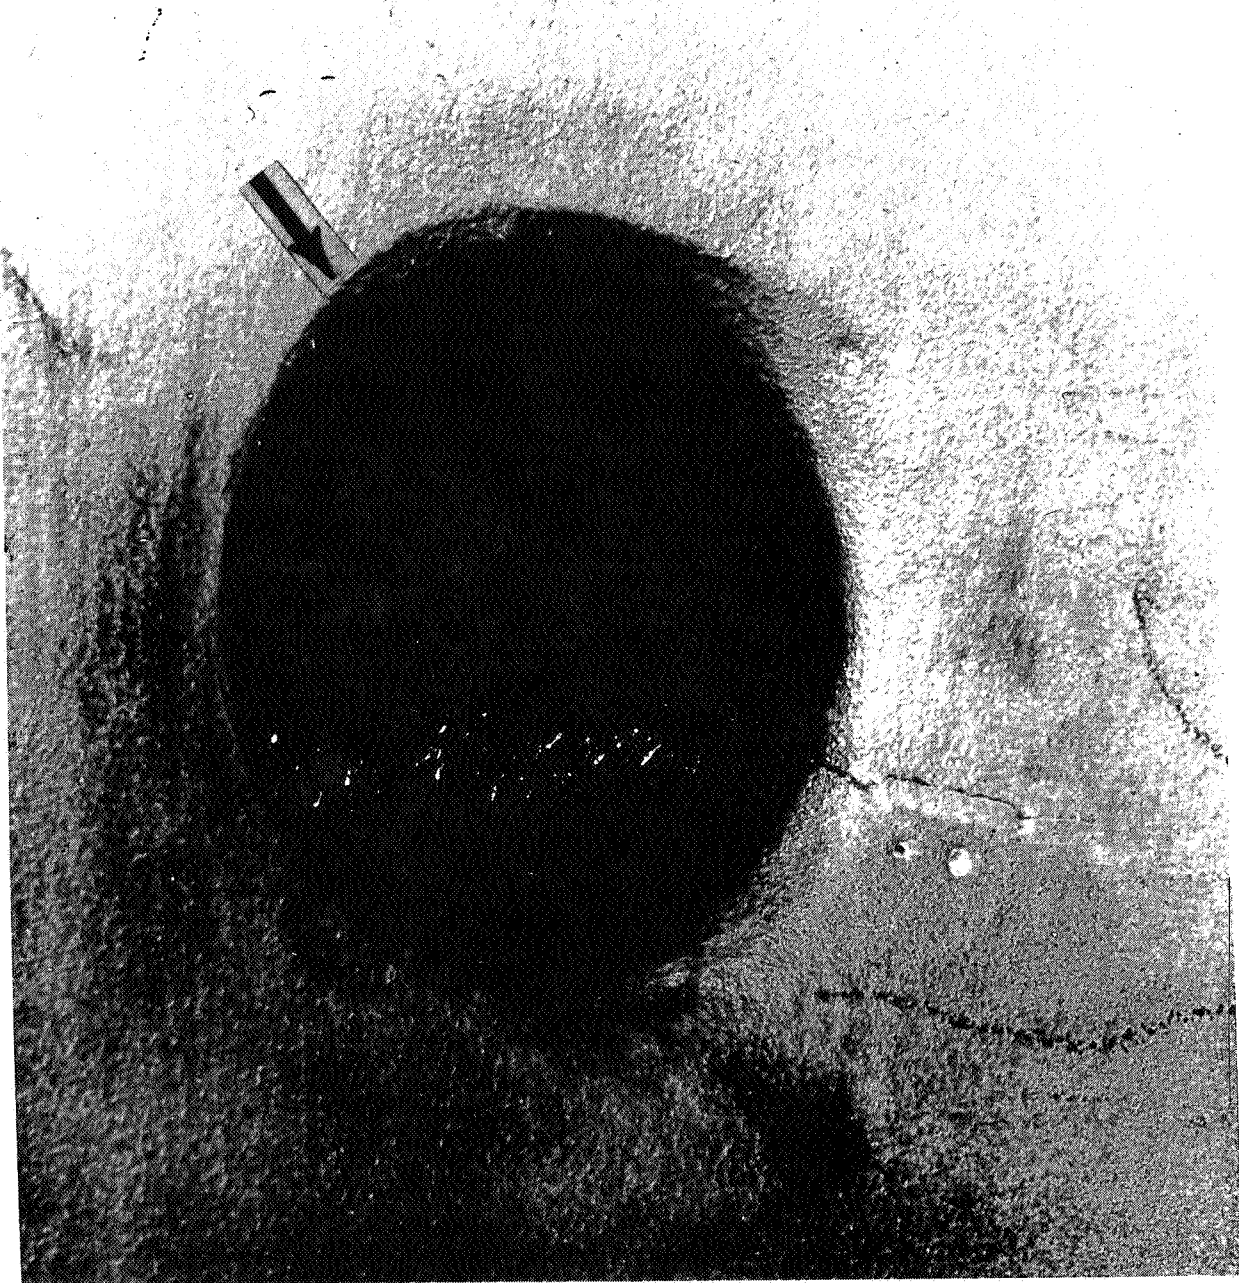
A visual examination of the leaking nozzle showed a large radial crack in the nozzle material oriented parallel to the longitudinal axis of the vessel. This crack extended approximately 3-in. up the nozzle bore and broke over the nozzle bore to the vessel inside diameter radius for a distance of approximately 1/3-in. A gap, approximately 0.01-in., was noted between the fractured surfaces. Dye-penetrant inspection showed another crack in the nozzle bore starting approximately 5-1/4-in. This crack was located approximately 130-degrees counter-clockwise from the other crack.

Figure No. 5 is a view of the nozzle showing the open crack. The other crack is located in the bore at the position indicated by the arrow. The contamination visible in the nozzle bore consists of metal chips and cutting fluid which were deposited during removal of the nozzle extension. A 4-1/2-in. inside diameter circular cutter was used to remove a plug containing the nozzle, the entire weld, and a 1/8-in.-thick section through the vessel wall layers. Examination of the plug showed both cracks had progressed to the cut surface. Also, the open crack had closed when removed from the restraint of the vessel wall. The extension of the crack from the bore to the cut surfaces of the vessel laminations is shown on Figures No. 6 and No. 7. Figure No. 6 corresponds to the open crack and Figure No. 7 to the crack restricted to the bore. The actual crack lengths are marked by arrows.

Figure 5
View of fractured nozzle from the vessel I.D. The open crack is visible on the lower right. The second crack is located in the bore at the position indicated by the arrow. The contamination in the bore is metal chips from the cutting operation.

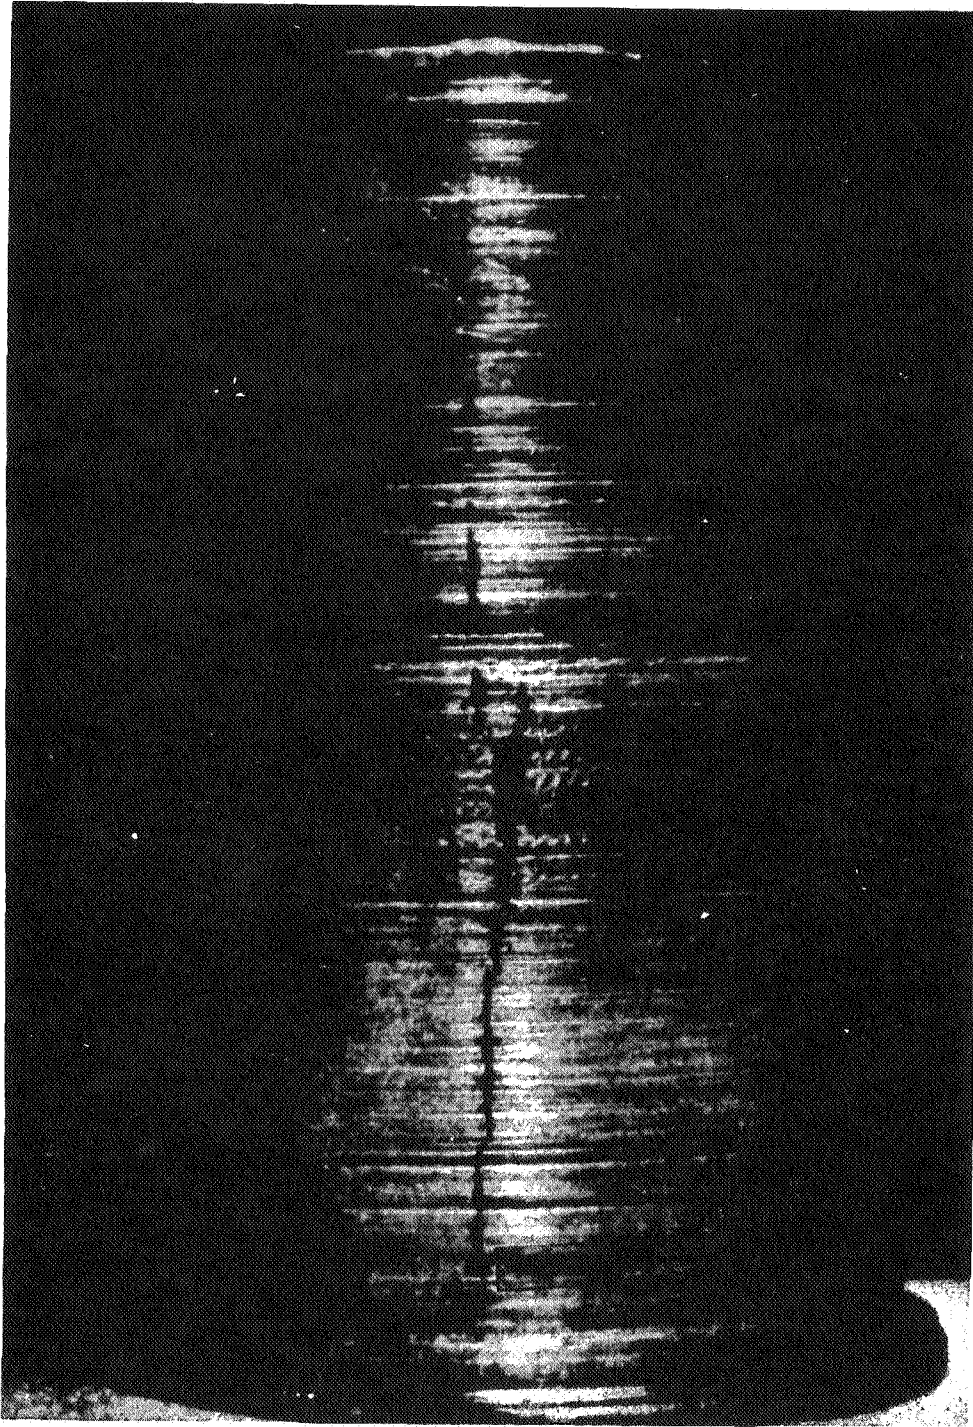
Figure 6
Cut surface of 4 1/4-in. plug showing extension of the open crack shown in Figure 5. Bottom of the figure corresponds to the vessel I.D. The crack extends between the arrows and is delineated by dry magnetic particle. (Mag: 1.3X)

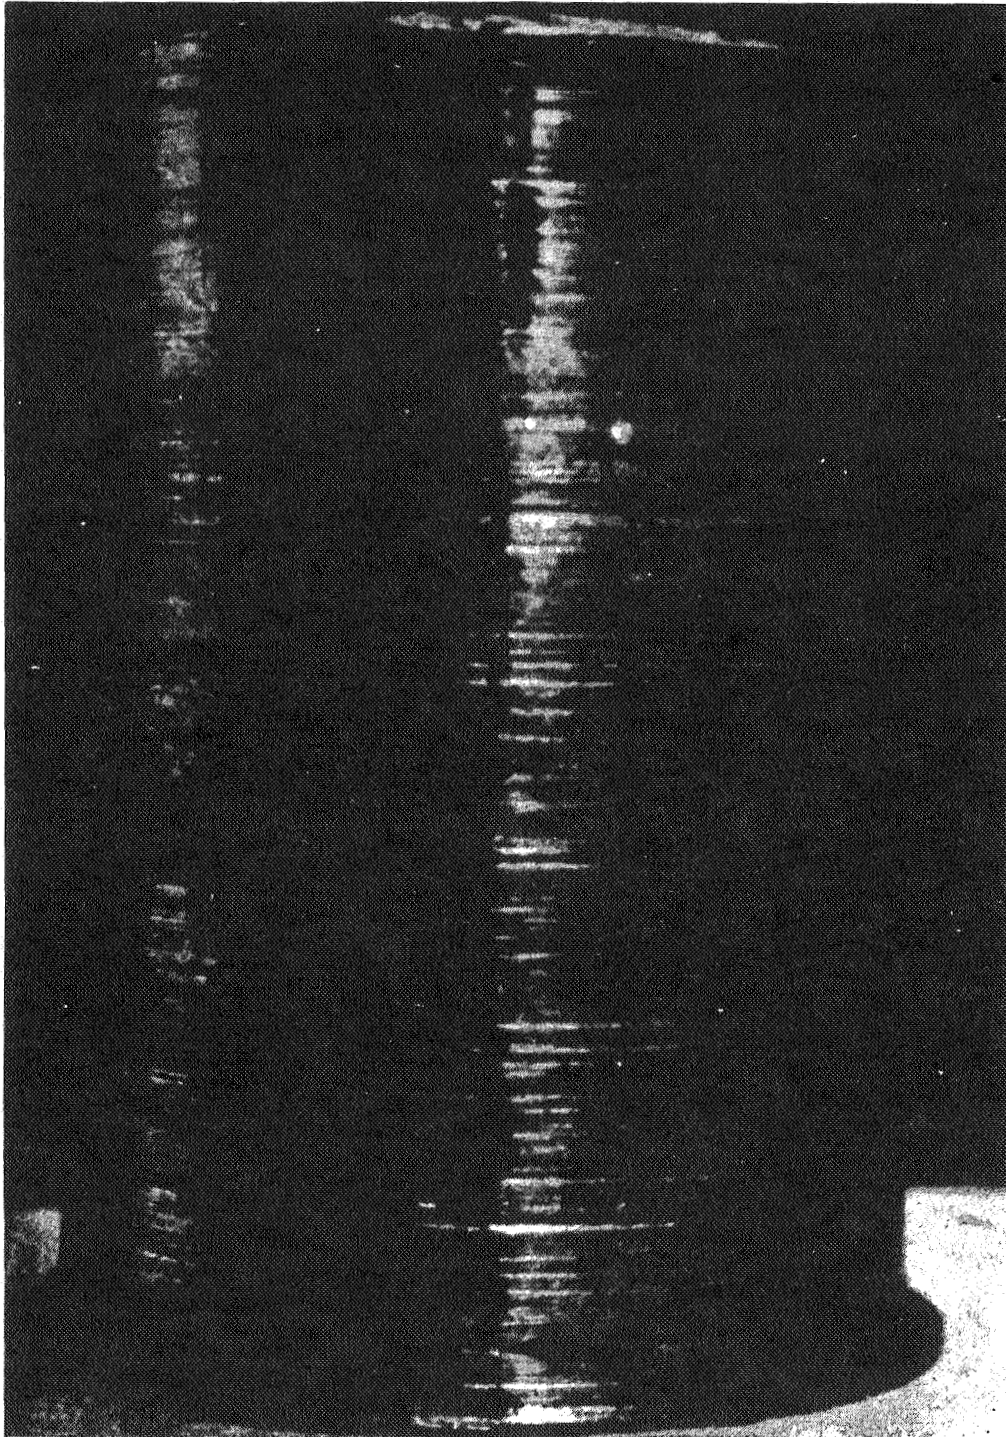
Figure 7

Cut surface of 4 $\frac{1}{4}$ -in. plug showing the extension of the crack in the nozzle bore. The crack extends between arrows and is delineated by dry magnetic particle. The bottom of the figure corresponds to the vessel I.D. Mag. 1.1X.

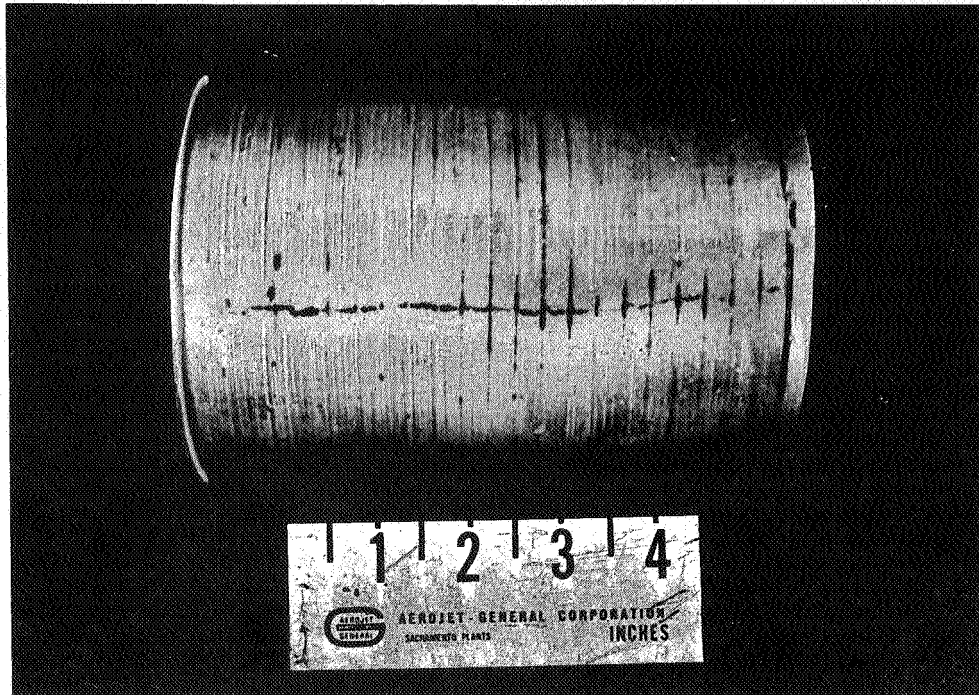
Figure 8
Cut Surface of 4-1/4-in. Plug Showing Extension of Crack
in the Nozzle Bore (With Dye Penetrant)

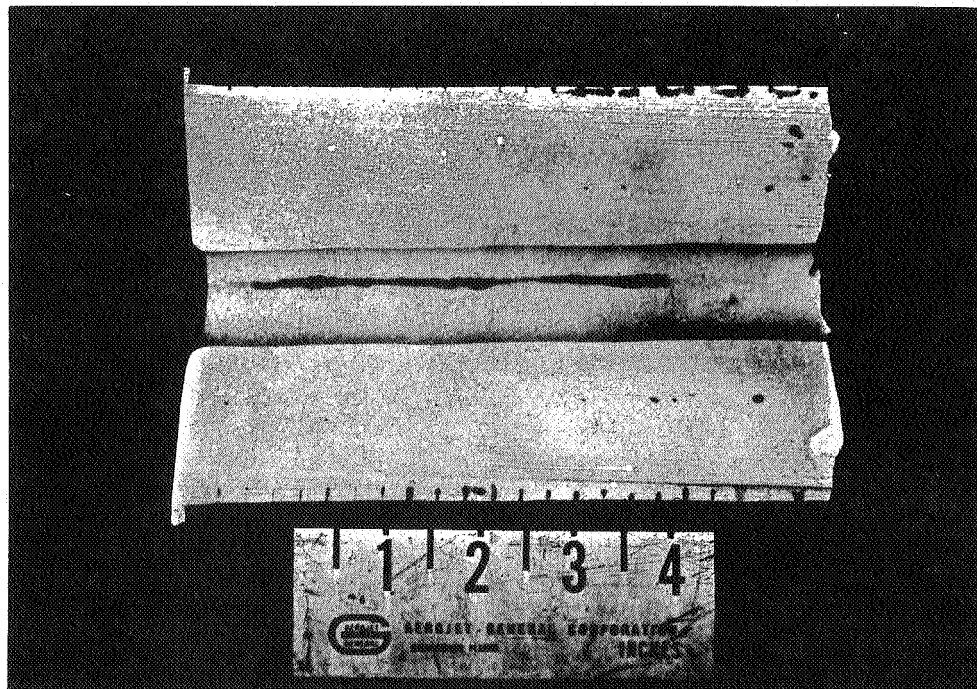
Figure 9
Cross-section showing nozzle bore crack corresponding to the crack
shown in Figures 7 and 8. This is also the same crack indicated by
the arrow in Figure 5. The left side corresponds to the vessel I.D.

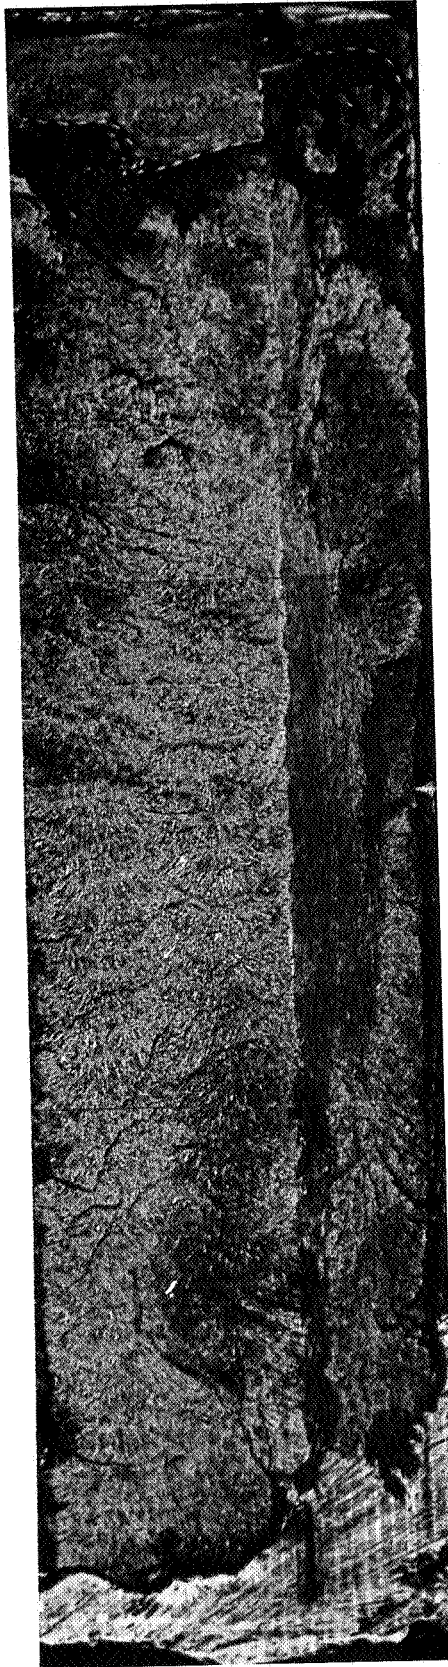
Figure 11

An enlarged view of the fractured surface shown on Figure 10. The saw cut to open the fracture is on the left. The portion fractured to separate the original fracture is outlined in white on the right. The right side is also the vessel I.D. This surface shows staining and oxidation which resulted from atmospheric exposure of the vessel and cutting fluid. The weld nozzle interface is indicated by the arrow at left and extends horizontally across the face. The portion above the arrow is the weld; the portion below, the nozzle. The cross-section at the white arrow is shown in Figure 13. (Mag: 2.5X)

figure as well as on the extreme right. The white outline indicates the area which was fractured in exposing the original fracture. This area also shows staining and oxidization which resulted from atmospheric exposure as well as cutting fluid contamination during the removal operation.

The original fracture surface shows two distinct textures; the flat zone, which extends from the nozzle to weld interface into the central portion of the nozzle material and tapers off at both ends; and the radial zone surrounding the flat zone.

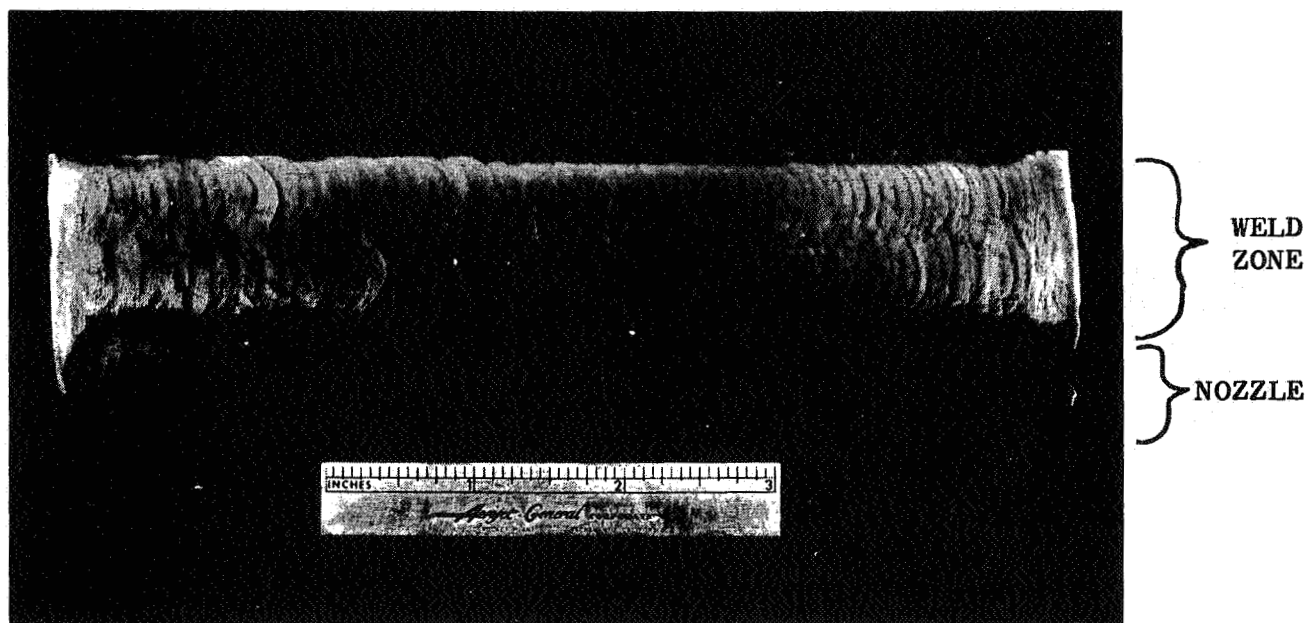
Figure 12

A longitudinal cut was made approximately 1/4-in. behind and parallel to each fractured surface and macroetched. A photograph of this surface is presented as Figure No. 12. The nozzle material is sound and the forging flow lines are evident. Some discontinuities are visible in the weld, but they do not appear excessive for this type of weldment. As shown on Figure No. 12, the nozzle material does not extend completely through the tank; the lower portion of the nozzle is built-up of weld material. The forging flow lines correspond to the longitudinal texturing on the flat fracture surface.

Macroetched cross section of the nozzle and weld.
Left side of figure is vessel I.D.

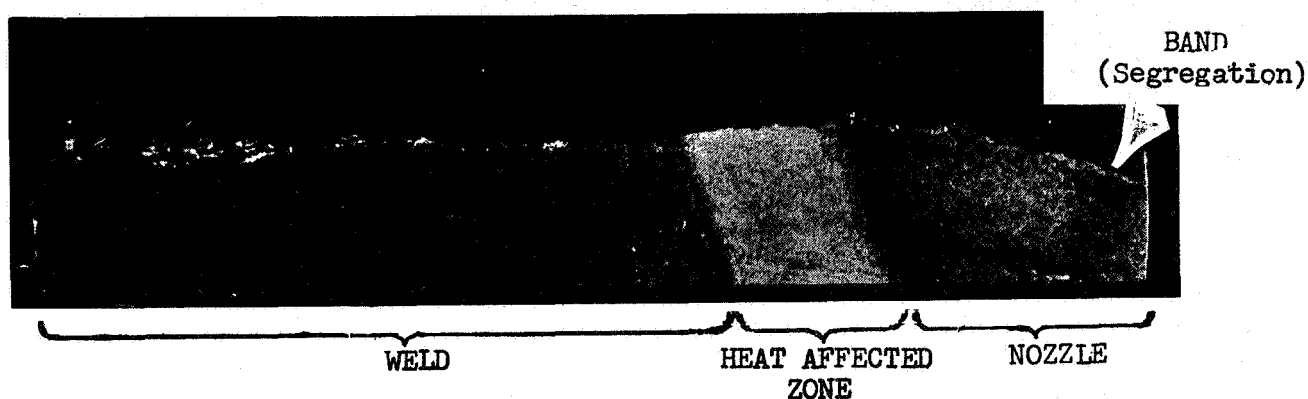
Figure 13

Examination of a longitudinal and transverse section of the fracture surface indicated that the cleavage fracture patch in the nozzle was through a band in the microstructure. A photograph of the transverse mount is shown as Figure No. 13. The left portion of the mount is the weld; the center lighter etching area is the heat-affected zone; and the right portion is the nozzle material. Note the light etching line along the fractured surface on the nozzle. This

Cross-section of fractures surface showing the flat fracture in the nozzle occurred through a band in the microstructure. This band is visible by the arrow on the right. It extends to the left and meets the fractured surface 1/2-in. left of the arrow and continues along the fractured surface. The light etching center portion is the nozzle HAZ, the left portion is the weld. This cross-section was taken at the white arrow as shown in Figure 11.

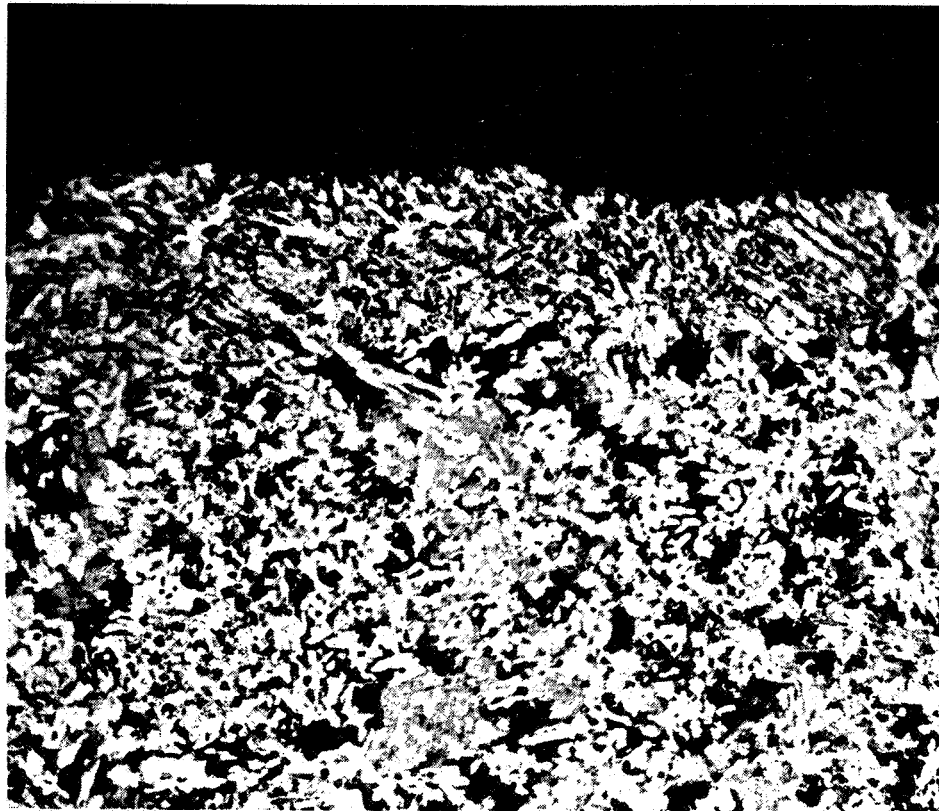
Figure 14

An enlarged view of the fractured surface in the nozzle showing the widmanstatten type of structure. The Knoop hardness in this area was 323. This type of structure was common to the flat fracture in the nozzle.

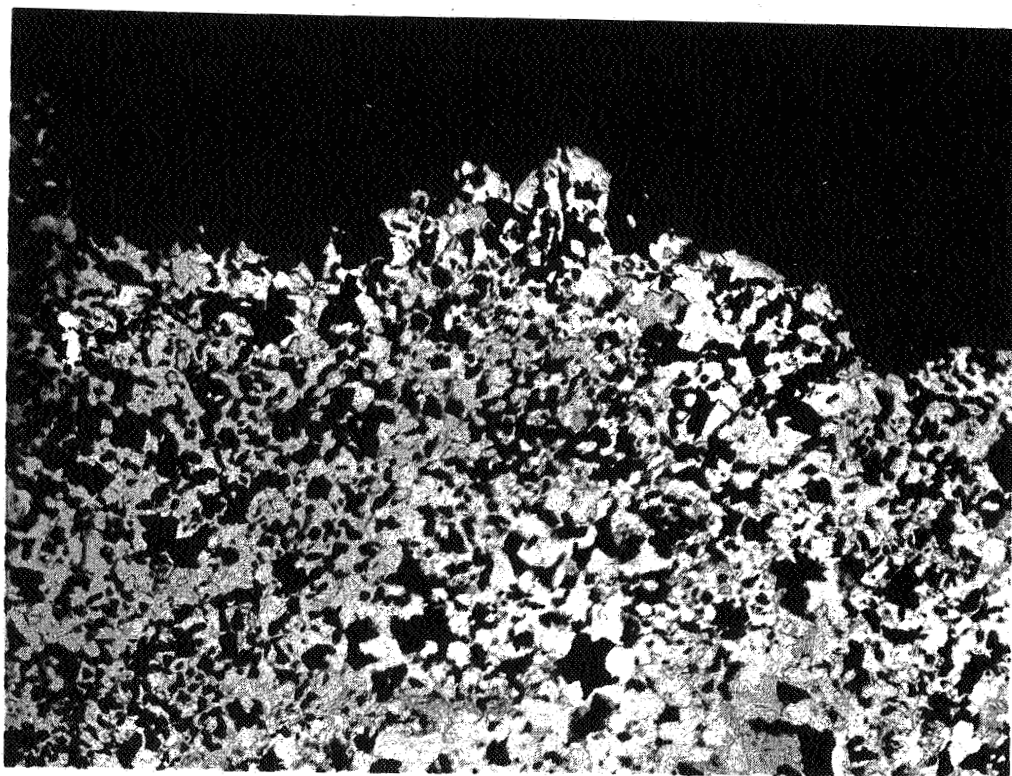
Figure 15: An enlarged view of the fractured surface in the radial fracture zone of the nozzle. The microstructure shows equiaxed pearlite and ferrite. The Knoop hardness in this area was 290. Etch: Nital Mag: 250X

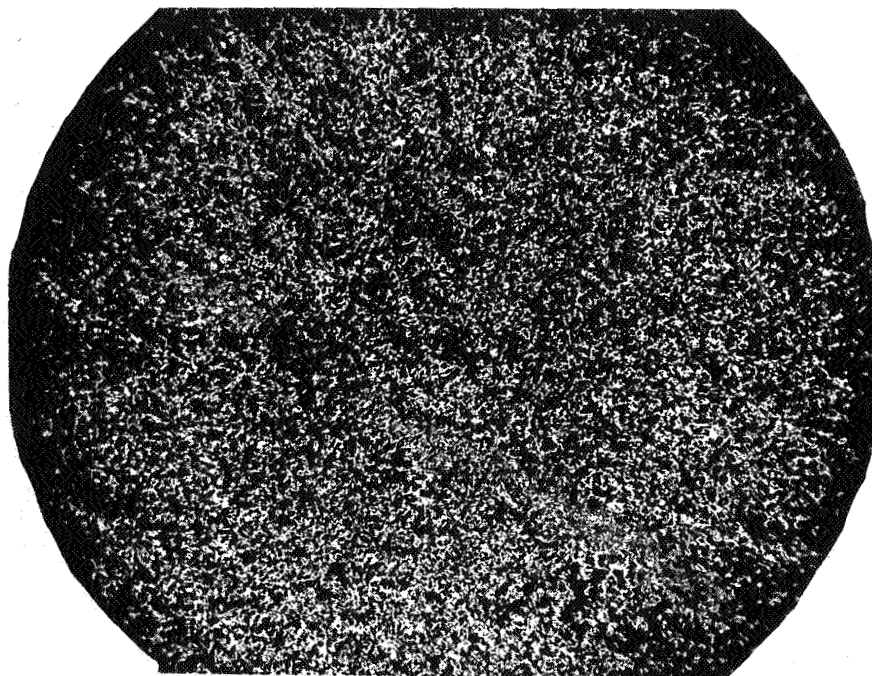
Figure 16: A band in the nozzle microstructure similar to the flat fracture path shown in Figure 14. This band is probably due to manganese segregation. Etch: Nital Mag: 40X

diffusion rate; therefore, the segregate can be carried to the finished product. These high manganese areas appear to have resulted in a Widmanstatten transformation structure when cooled from the normalizing temperatures. The microstructure appears to be partially bainitic, and combined with the strengthening effect of the manganese, can result in the increased hardness measured in these areas.

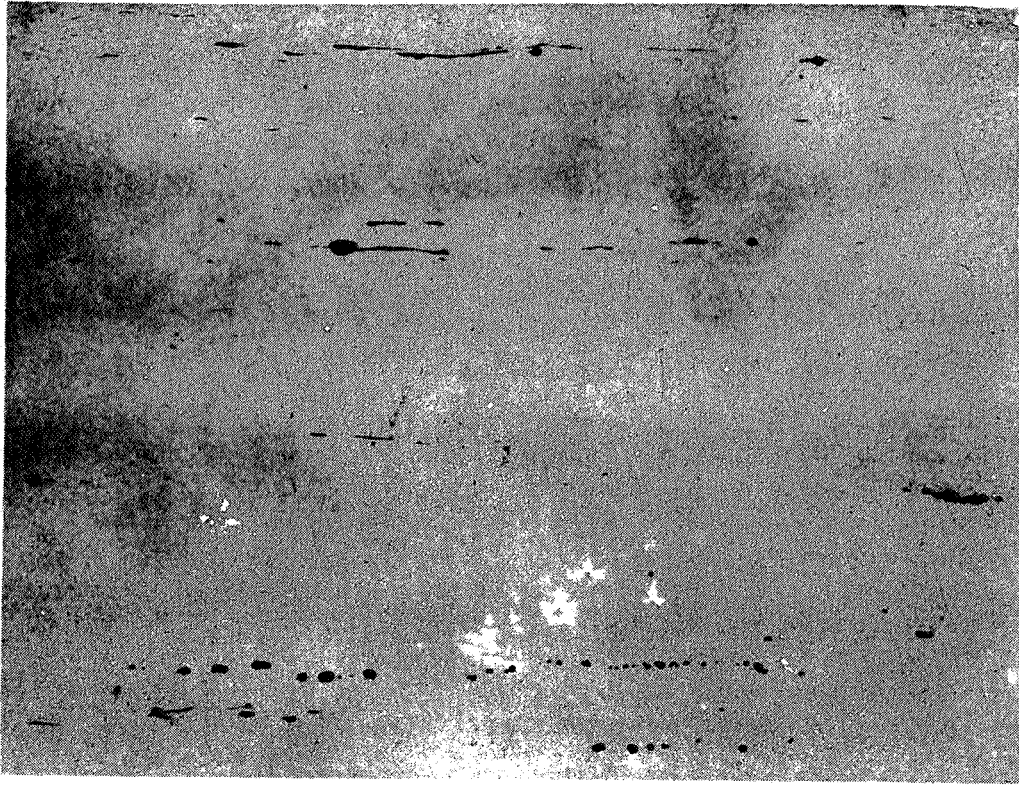
Figure 17: Nonmetallic inclusion content in the nozzle material.
It is not excessive for this steel.

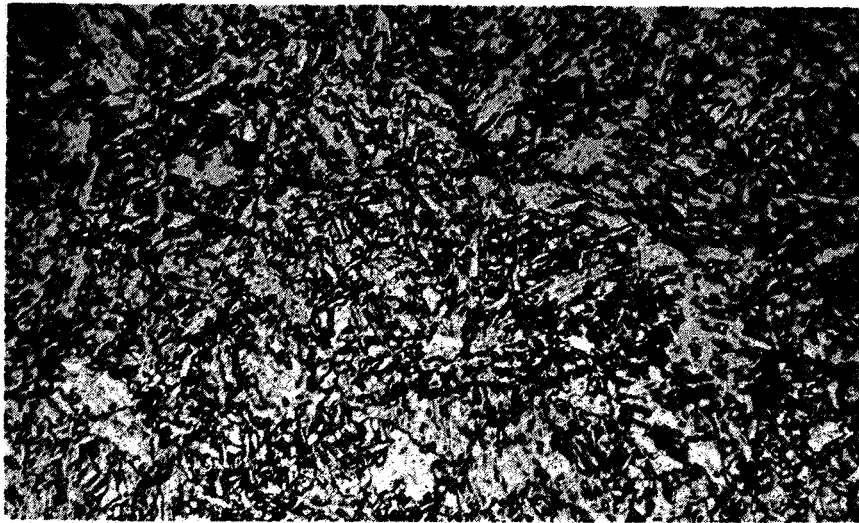
There are no inclusion specification requirements and the ratings are considered satisfactory. The typical microstructure is shown on Figure No. 18, where the weld microstructure appears sound and normal. As anticipated, no evidence typical of high temperature hydrogen damage, such as microfissuring and decarburization, was noted during the examination.

Figure 18: Typical microstructure of the "as-deposited"
weld metal.

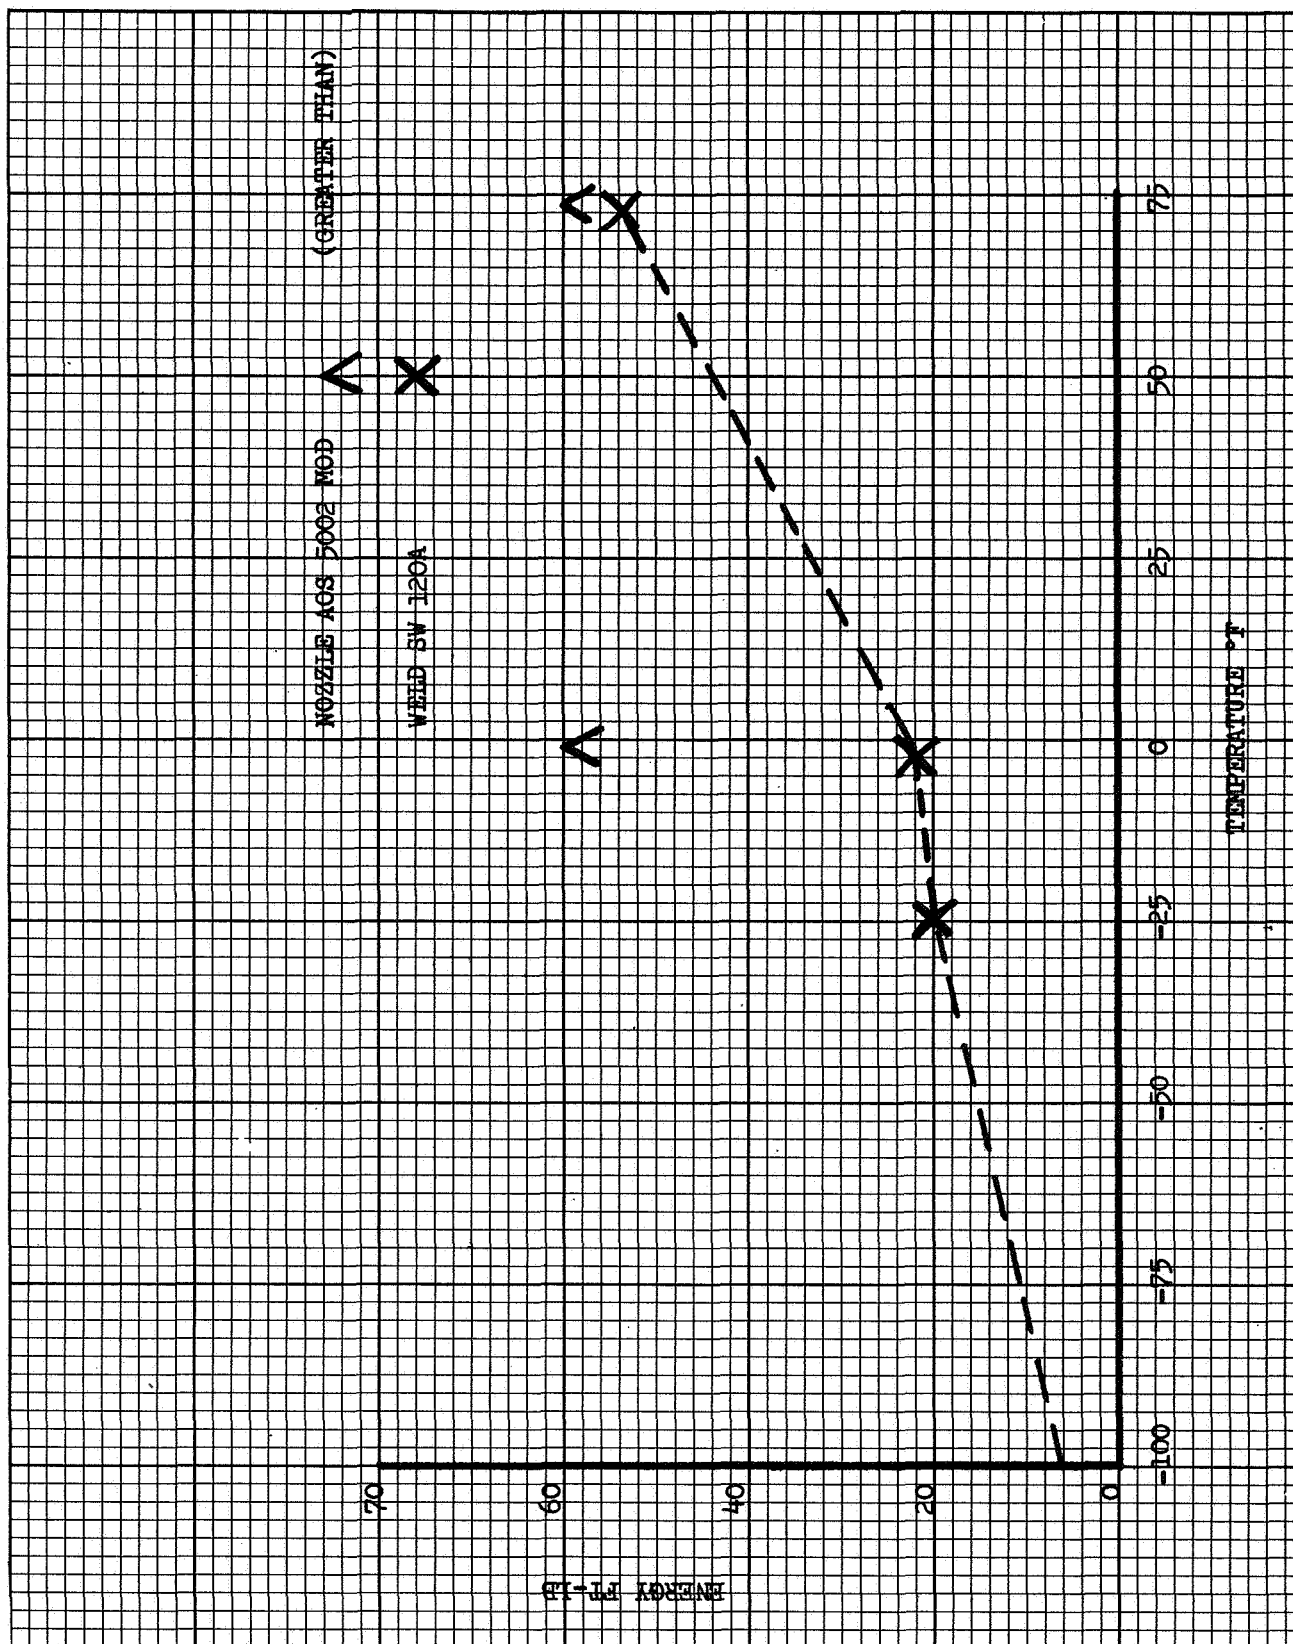
Figure 19: Charpy V-notch Impact vs. Temperature (1-in. nozzle and weld material, VH-74)

A review of the test results shows a ductile-to-brittle transition temperature of well below 0°F for both materials. The lowest ambient temperature recorded during the three days prior to failure was 40°F. The temperature at the time of vessel failure was approximately

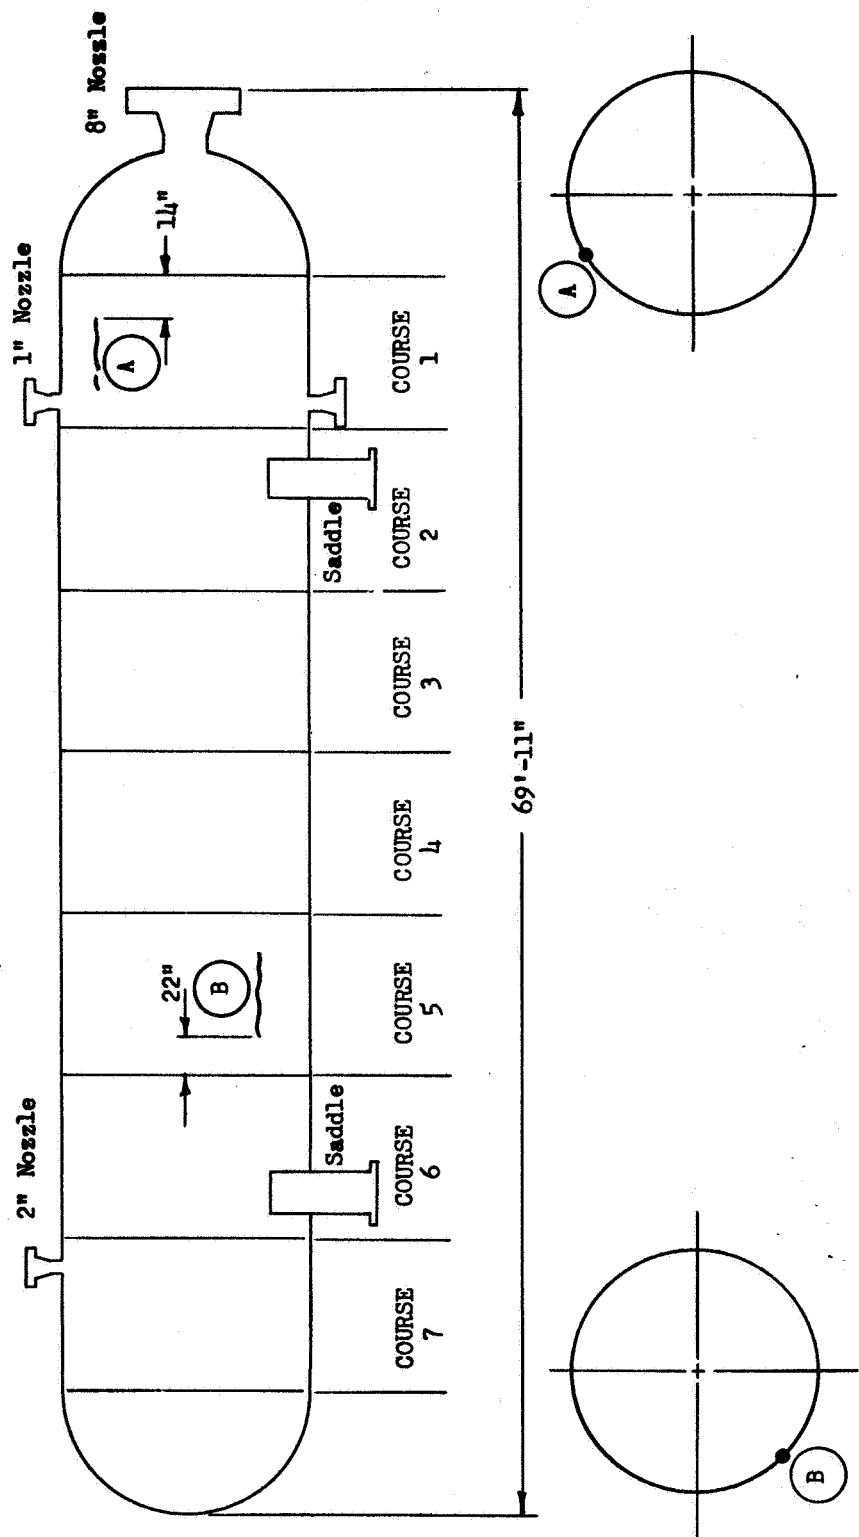
Figure 28: Receiver VK-11, Location of Failure Crack and Other Defects

22" crack along longitudinal seam weld, starting 14" from head to shell weld. Second crack along same line 2 1/2" long, starting 50" from head to shell weld

50" crack along longitudinal seam weld, starting 22" from course 5/6 girth weld. Crack is continuous thru 1st layer

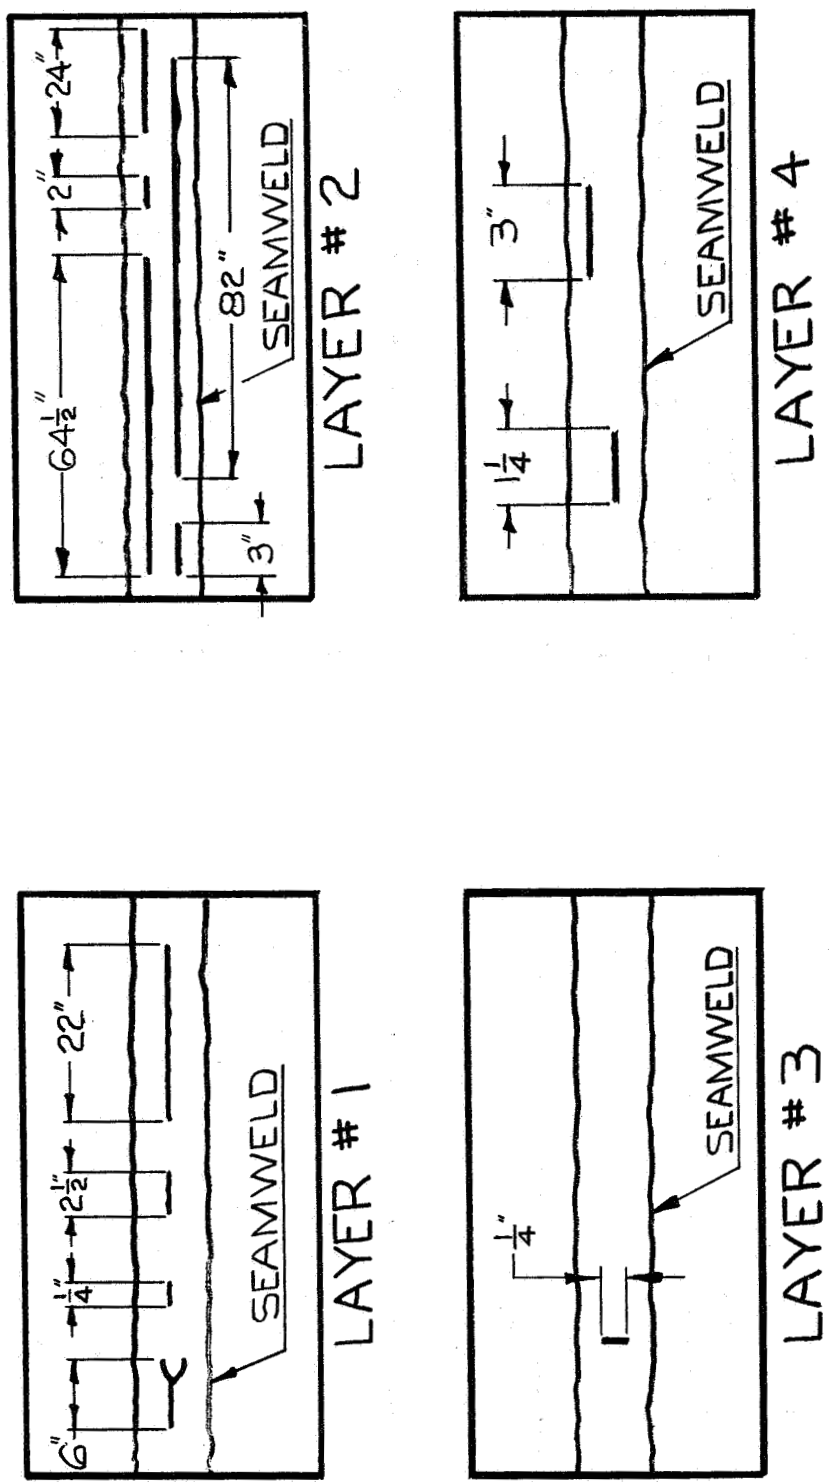
Figure 29: Receiver VK-11, Location of Cracks, All Layers of Course No. 1

INSIDE SURFACE LAYERS OF COURSE No. 1

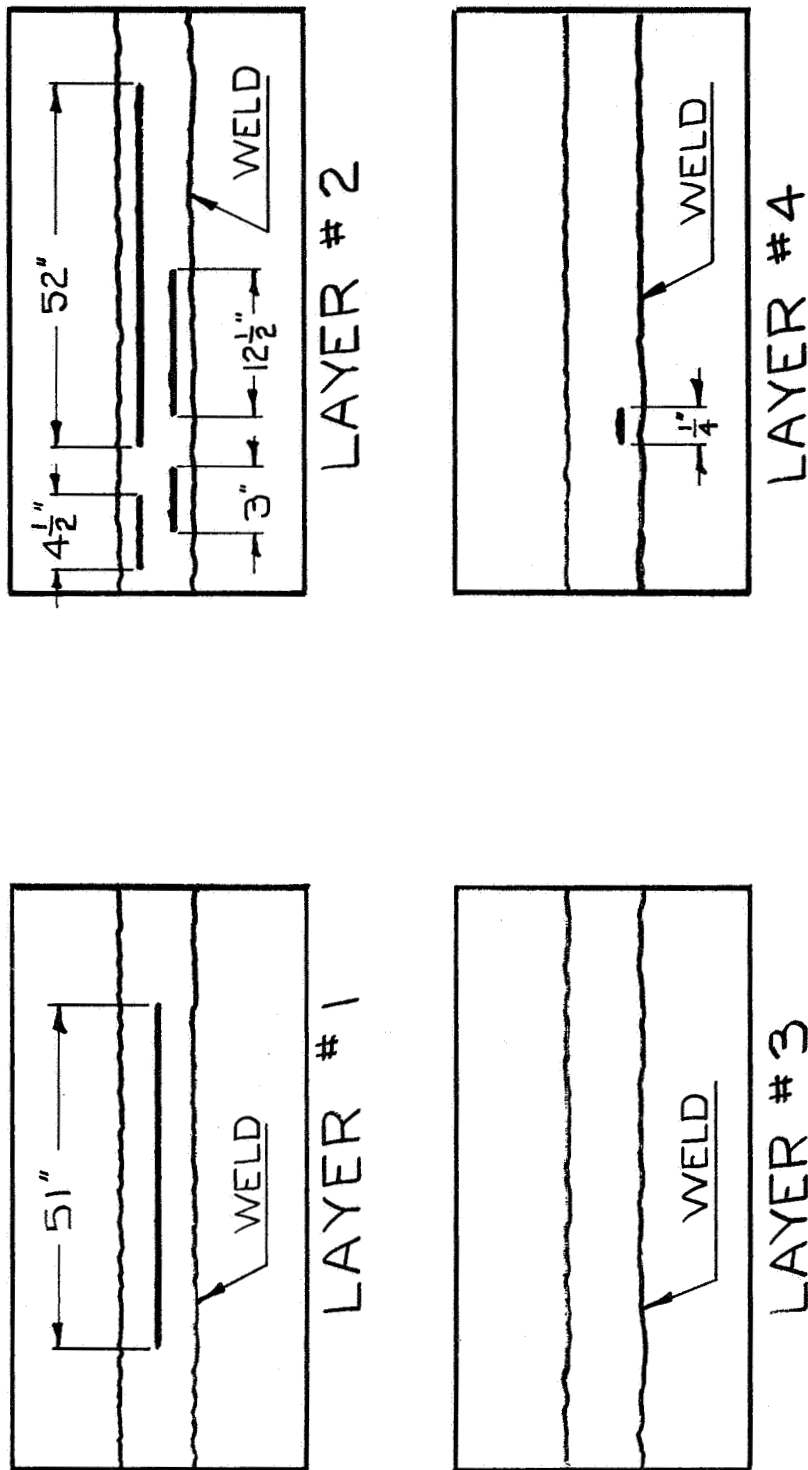
Figure 30: Receiver VK-11, Location of Cracks, All Layers of Course No. 5

INSIDE SURFACE LAYERS OF COURSE No. 5
